Instrumentation, Field Testing, and Fatigue Evaluation of Selected Approach Spans of the Throgs Neck Bridge (TN82) over the East River, New York

Final Report

Prepared for
Parsons
TBTA

ATLSS Report No. 06-17

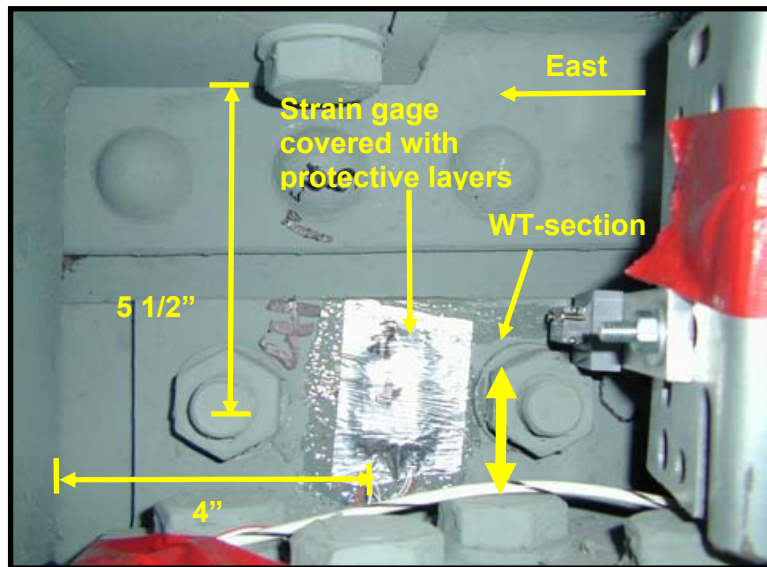
Figure 4.4 – Strain gage CH_41 installed in Span 35 on the web of Floorbeam 2 at the floorbeam/east girder intersection and at a distance of approximately 21 1/2" west of the centerline of the east girder and approximately 5 1/2" below the bottom face of the floorbeam top flange (view looking south)

Different repair types for the web of end floorbeams and various intermediate floorbeams were installed in Span 35, 36, and 45. The retrofit included bolting a WT-section to the web of the floorbeam to increase the cross sectional area of the web at that location and reduce the out-of-plane stresses on the web induced by the lateral bracing system (the top lateral bracing system is bolted to the WT's through gusset plates). Strain gages were installed transversely on the WT's to measure the effectiveness of the retrofit in reducing the out-of-plane stresses. Specifically, strain gages CH_41, CH_18, and CH_15 were installed on the WT of Floorbeam 2 in Span 35 (south face of floorbeam web), the WT of Floorbeam 8 in Span 36 (north face of floorbeam web), and the WT of Floorbeam 2 in Span 45 (north face of floorbeam web), respectively.

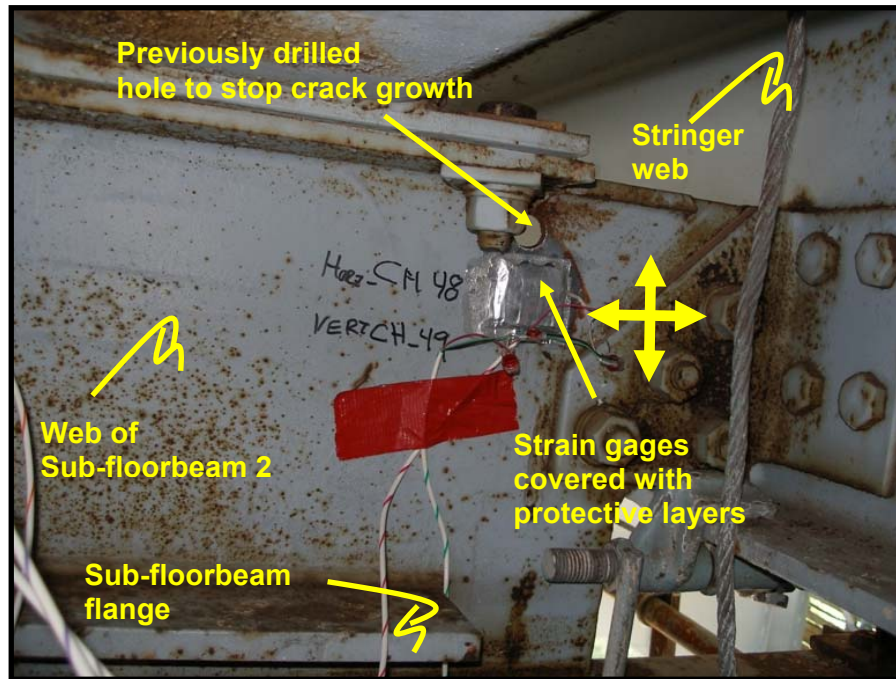
The existence of the cracks on the web of the sub-floorbeams prevented the installation of the gages near the blocked flanges. This resulted in the peak stresses on the sub-floorbeam web not being captured. It is important to note that this type of crack exist in the web of sub-floorbeams in various approach spans and typically are located on the web of the two north end sub-floorbeams and the two south end sub-floorbeams. The sharp reentrant corner resulting from flame cutting the flange and the notch conditions resulting from the cutting process are high stress raisers that resulted in significant reduction in the fatigue strength of the detail, which otherwise would be classified as Category A detail per AASHTO Specifications. It is highly likely that cracking at the detail could have still occurred even if the notches were ground smooth. This is due to the existence of the sharp reentrant corner of the blocked flange.

Figure 4.10 – Horizontal strain gage CH_48 and vertical strain gage CH_49 installed on the south face of the web of the Sub-floorbeam 2 in Span 38.
(view looking north)

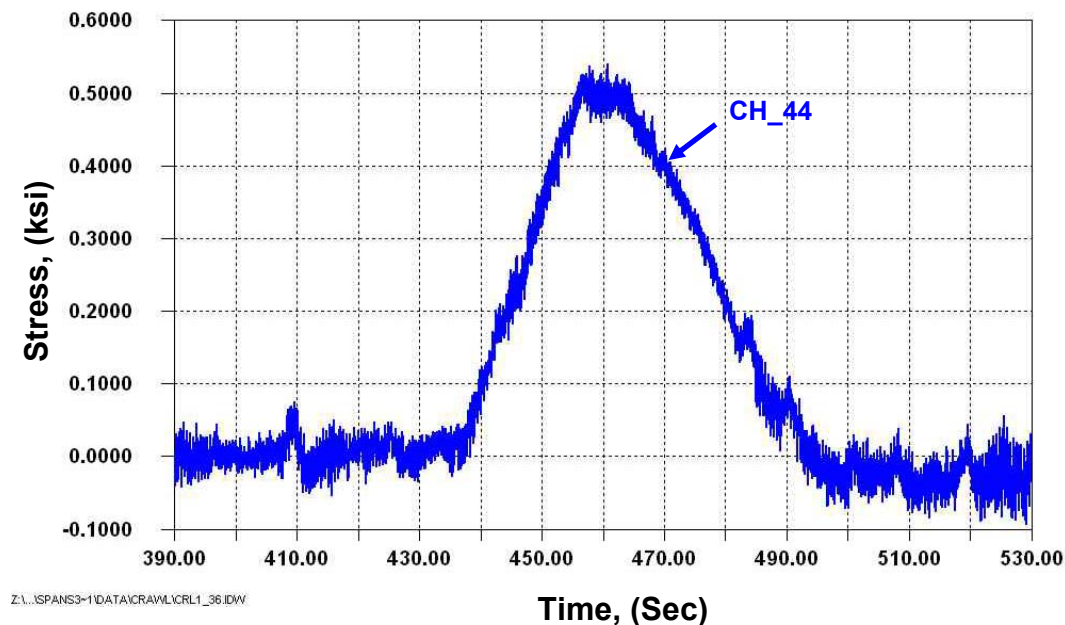
Cracks have been discovered on the web of various floorbeams where the top lateral bracing system frames into the floorbeam web. Strain gage CH_44 was installed on the web of Floorbeam 2 in Span 38 (the control span) to assess the magnitude of the stress range experienced by the detail and to serve as a baseline for comparison between the response of the non-retrofitted floorbeam web of Span 38 and those where prototype retrofits have been installed in Span 35, 36, and 45.

The response of the strain gage as Truck 2 crossed in the northbound direction over Span 38 in the outside lane in the crawl test CRL1_36 is shown in Figure 5.4. A summary of the maximum stress, minimum stress, and stress range values experienced by the gages in the crawl tests, including the multiple presence truck test is presented in Table 5.11. It is important to note that this detail can be classified as Category B detail per AASHTO Specifications. The maximum stress range measured during the crawl controlled load tests is 1.3 ksi, which is considerably below the CAFL of the detail (16 ksi). The low measured stresses could be a result of not placing the gage at the critical location on the web.

Figure 5.4 – Response of strain gage CH_44 installed non-retrofitted web of Floorbeam 2 at the floorbeam/east girder intersection and at a distance of approximately 21 1/2" west of the centerline of the east girder and approximately 5 1/2" below the bottom face of the floorbeam top flange in Span 35 (south face of floorbeam web) as Truck 2 crossed in the northbound direction in the outside lane in the crawl test CRL1_36.

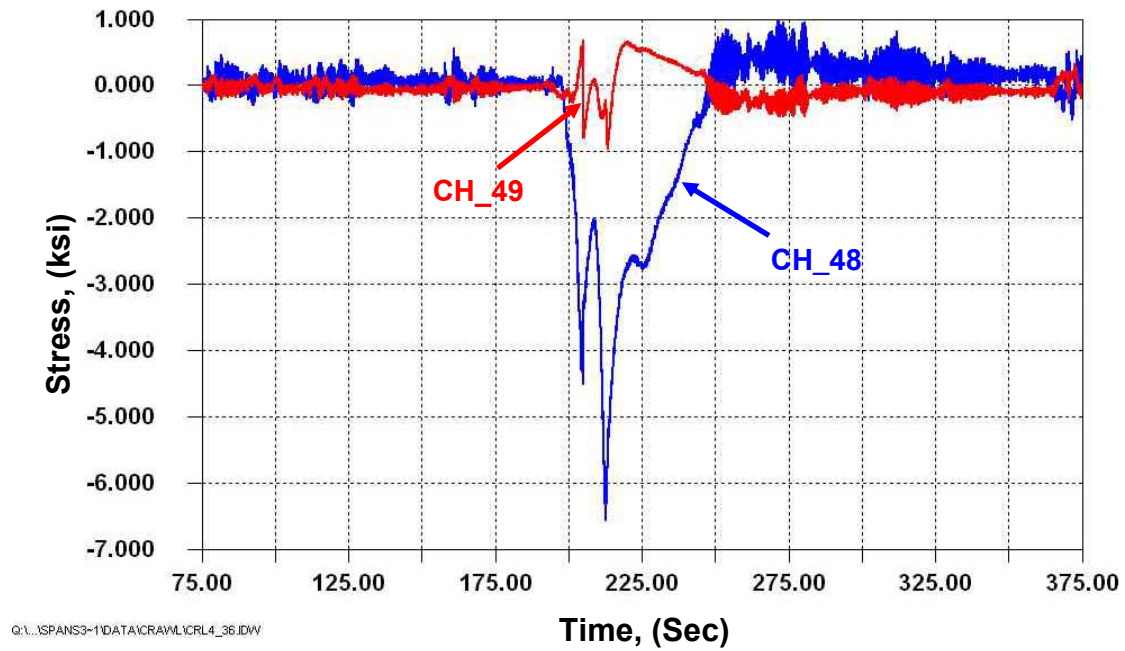
As previously discussed, cracking has been observed at the two northern-most sub-floorbeams and the two southern-most sub-floorbeams in many of the approach spans. The cracks appear to have originated at the reentrant corner of the flame cut blocked top flange and propagated downwards in the web of the sub-floorbeam. The notch and the reentrant corner condition of the detail would not provide more than a Category E' fatigue resistance, that otherwise could have been a Category A if properly fabricated.

is approximately 50% less the stress range value of 6.4 ksi measured by strain gage CH_48 during the same controlled (strain gage CH_48 was installed in Span 38 at approximately 1 3/4 in lower than the location of strain gage CH_13 installed in Span 34). The maximum stress range measured by gages CH_14, CH_15, and CH_16 was found to be equal to 1.2 ksi. It is important to note that the only prototype retrofit installed in Span 34 was the prototype shear connectors.

Figure 5.15 – Response of strain gages CH_48 and CH_49 installed horizontally and vertically, respectively, on the south face of the web of the Sub-floorbeam 2 in Span 38 as Trucks 3, 4, and 5 crossed in the northbound direction over the span in the controlled load test CRL4_36

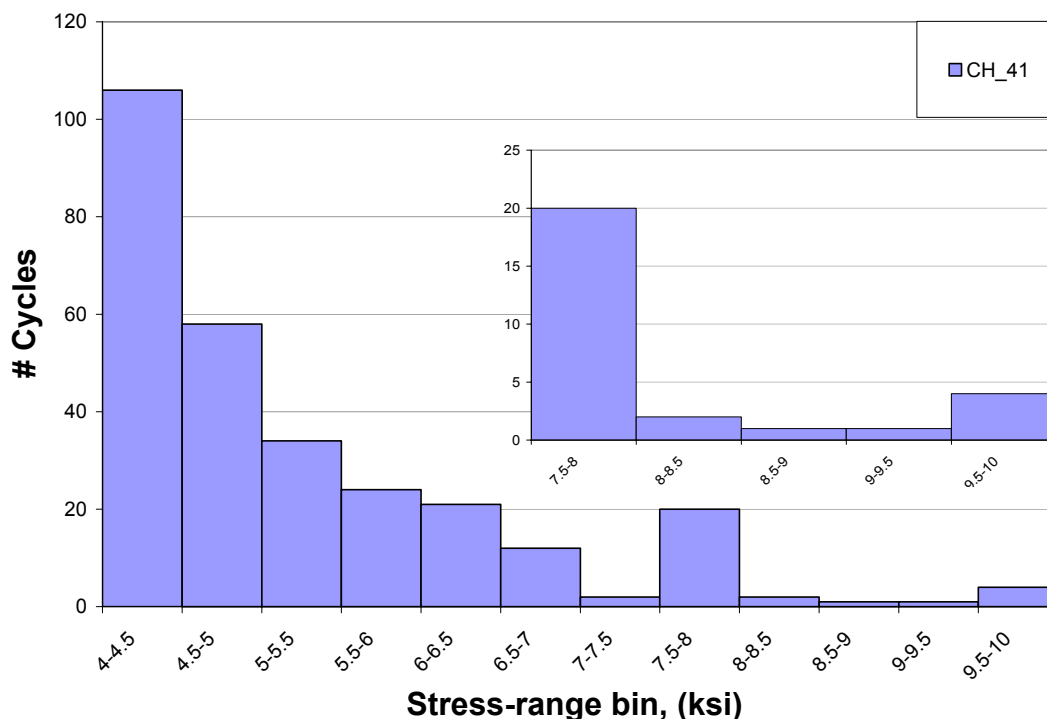
Figure 6.3 – Stress-range histogram for strain gage CH_41 installed on the WT bolted to the web of Floorbeam 2 (on the south face of the floorbeam web) in Span 35

As previously noted, WT-sections were bolted to the web of selected floorbeams to increase the cross sectional area of the web and reduce the out-of-plane stresses induced on the web by the lateral bracing system. Strain gages CH_41, CH_18, and CH_15 were installed on the WT of Floorbeam 2 in Span 35 (south face of floorbeam web), the WT of Floorbeam 8 in Span 36 (north face of floorbeam web), and the WT of Floorbeam 2 in Span 45 (north face of floorbeam web), respectively. The gages were installed on the WT's bolted to the web of the floorbeams at the floorbeam/east girder intersection and at a distance of approximately 21 1/2 in west of the centerline of the east girder and approximately 5 1/2 in below the bottom face of the floorbeam top flange.
